ELECTRICAL INTERFERENCE SOLUTIONS, INC.

RFI REPORT OF FINDINGS

Date: April 29, 2011

TSS159 post insulator hardware.

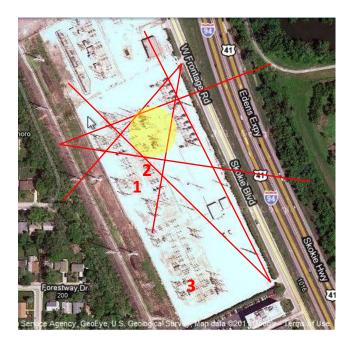
Identified Sources:

The dominant interference pattern is from AA9VI on February 13, 2011. The identified source (1) was isolated to one of two adjacent post insulators by the signature, and identified using the ultrasonic dish.

A second source (2), previously identified by ComEd, was louder. But, the signatures did not match.

In each case the sources are at the clamps at the bus bar at the top of the insulators.

A third strong source (3) was located on the 138kV bus, also at the top of an insulator, also with a different signature.

Source "1" matches the signature of the problem noise at AA9VI. So, it would be prudent to address source "1" first.

If problems persist, then signature analysis should be used to determine if source "2", source "3", or some other source should be addressed.
