# Compliance Tests on Overhead Injector on Slaughter Rd at Woodchase

# Compliance with Emission Limits

# BPL Notching

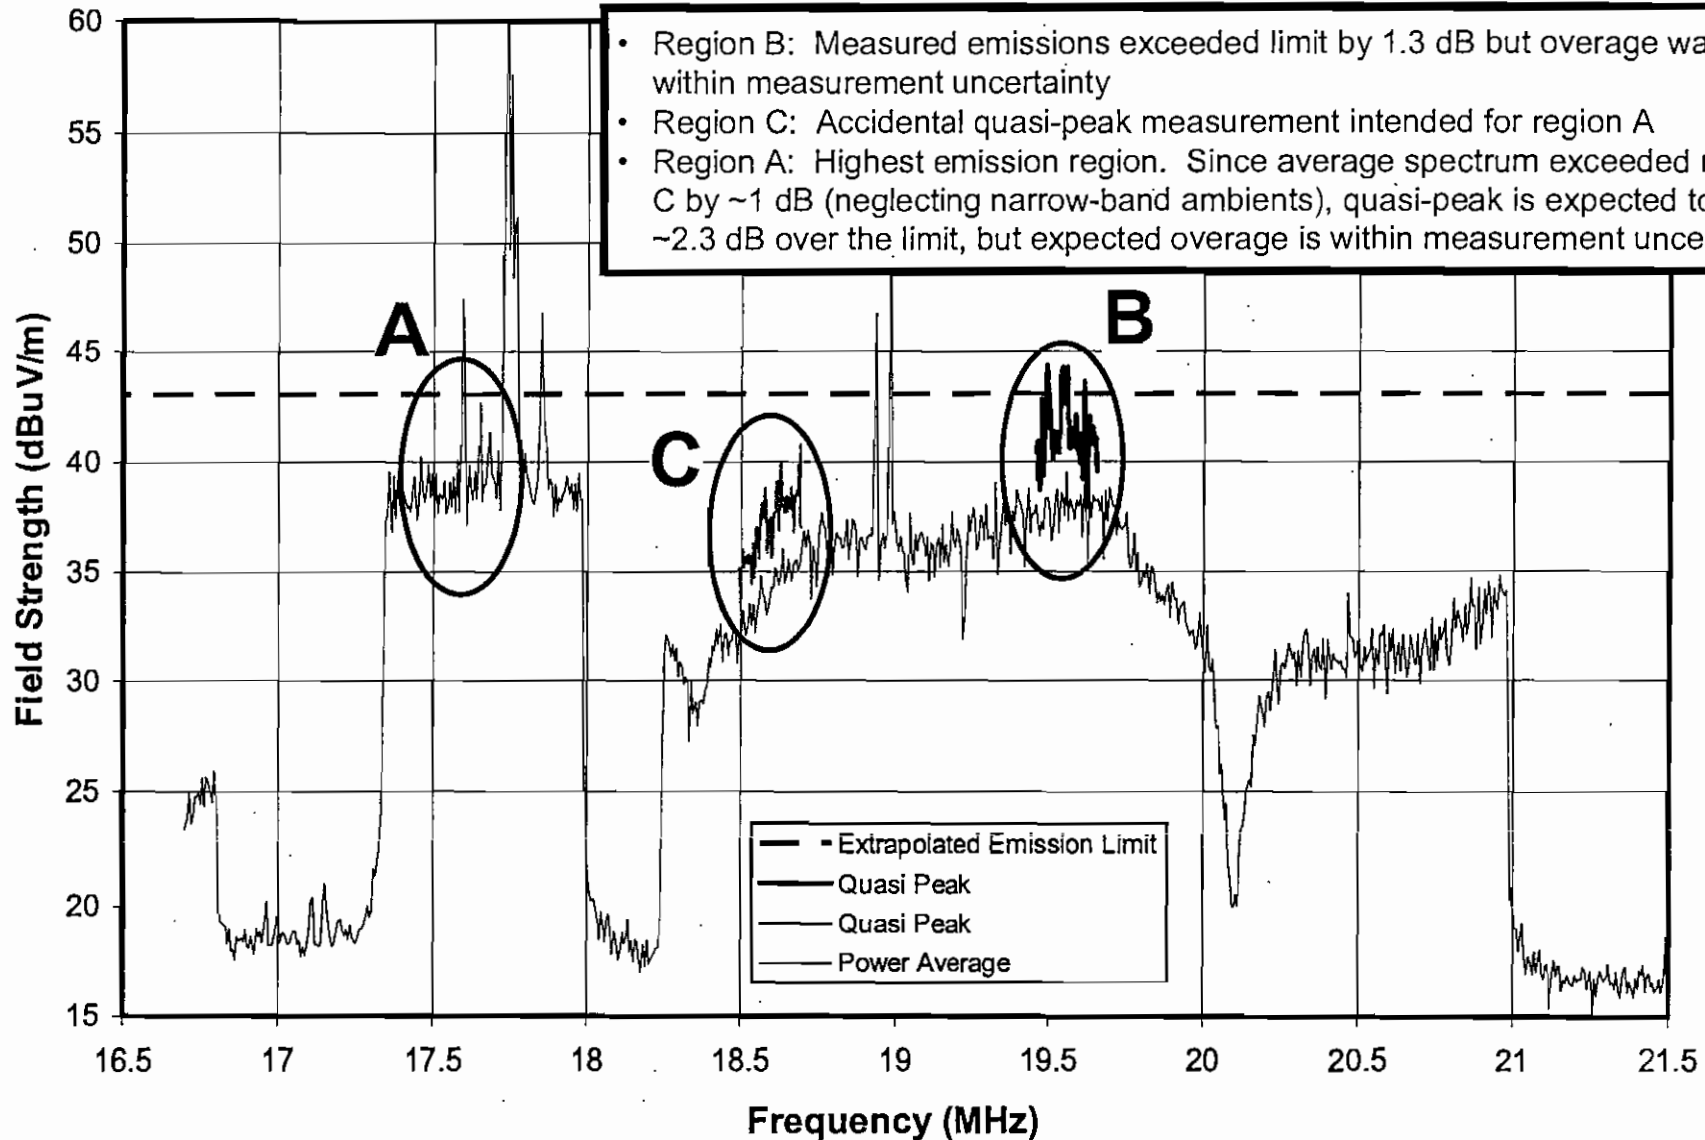
# Compliance Tests on 19.2-MHz Overhead Injector on Holland Church Rd

- Region B: Measured emissions exceeded limit by 1.3 dB but average was within measurement uncertainty
- Region C: Accidental quasi-peak measurement intended for region A
- Region A: Highest emission region. Since average spectrum exceeded region C by ~1 dB (neglecting narrow-band ambients), quasi-peak is expected to be ~2.3 dB over the limit, but expected average is within measurement uncertainty

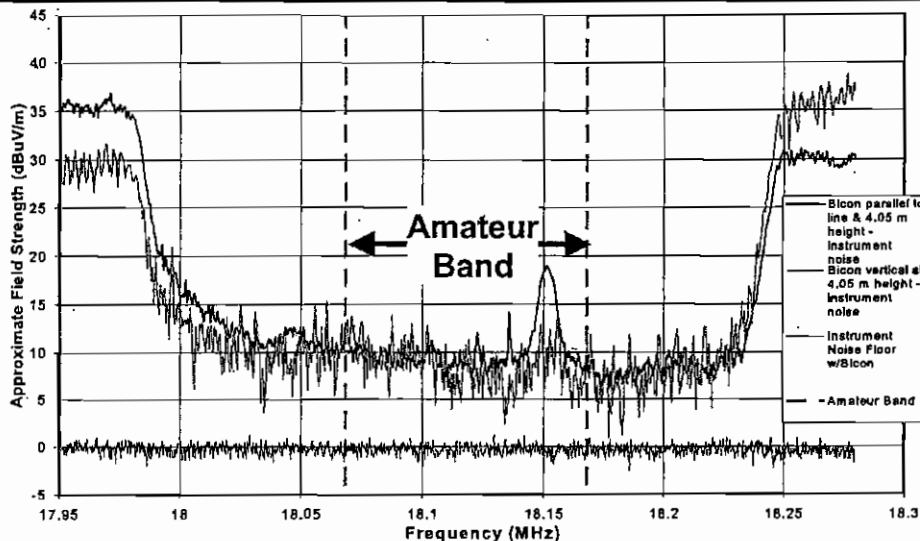
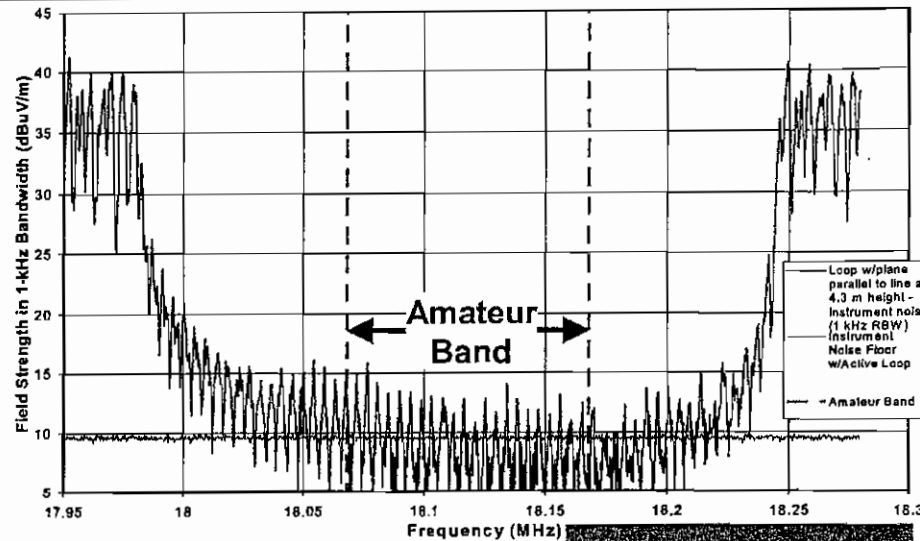
# Notch Depth

- Notch depth of only unit with complete notch (19.2 MHz injector on Holland Church Rd) was measured in two ways
  - Evaluated spectrum band averages in two moderate-resolution (9 kHz) spectra from bicon antenna
  - Evaluated OFDM peaks in high resolution (1-kHz) spectra from loop antenna
  - Results ranged from 23.4 to 25.0 dB, with an average of 24 dB
- Carrier structure indicates that bottom of notch was filled in by BPL signal—not by ambients or general power line noise.

**Notch Depth is 24 dB**

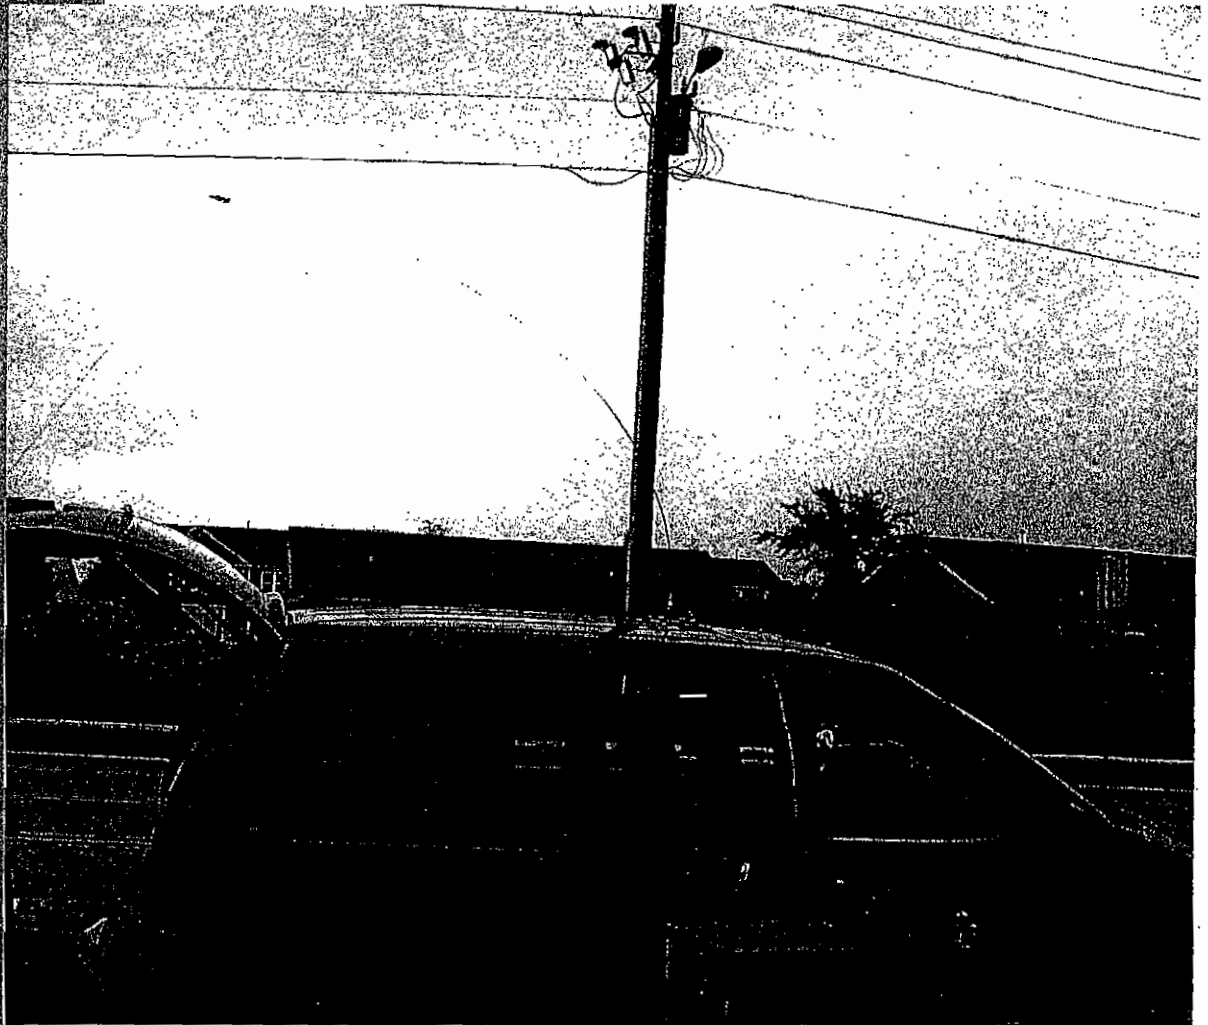
## Site 1 – Shoulder of James Slaughter Rd

# Radio Tests of Notch Effectiveness

**Recommendation: Increase notch width by 100 kHz at low end of 10m band (28 MHz)**

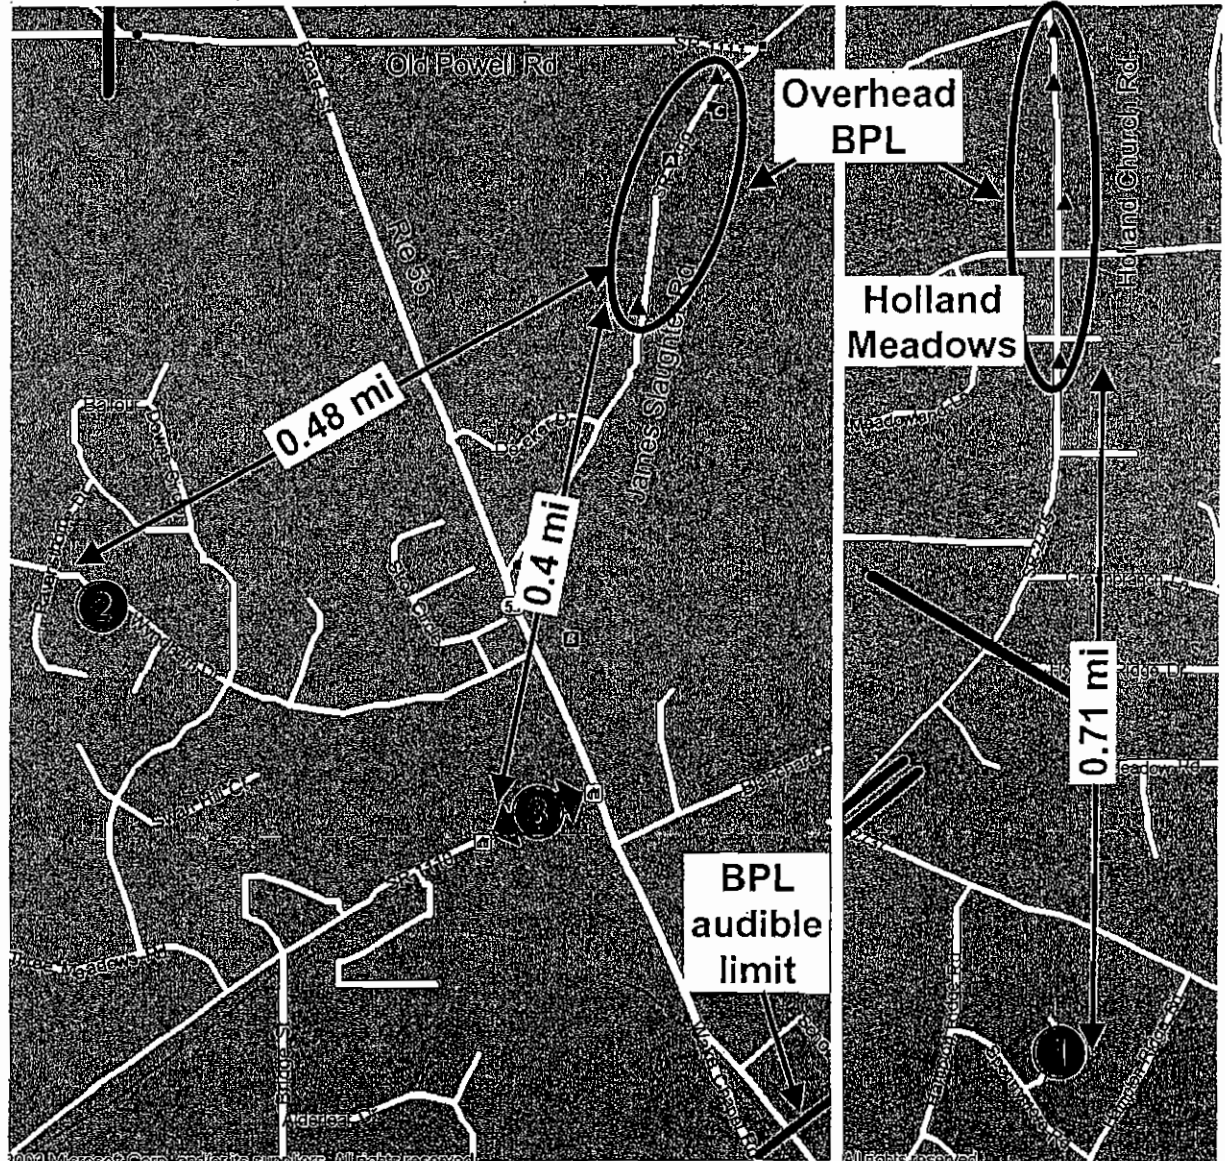
# Fixed Amateurs

- Fixed amateur locations included in complaint
  - ① 5813 Heathill Ct.
  - ② 509 Wyndham Dr
  - ③ 201 Wilbon Rd 301B
- Interference not audible w/mobile antenna at ① & ②, even outside of notches
- ③ not visited due to a mapping error. Location uncertain, but may be close enough to overhead lines on Rte 55 to detect un-notched BPL signals on mobile unit.
- No testing was performed with the fixed HF amateur antennas at any of the locations
